Donald Insall Associates
Chartered Architects and Historic Building Consultants

Stroud Chapels of Rest - Feasibility Assessment

September 2021

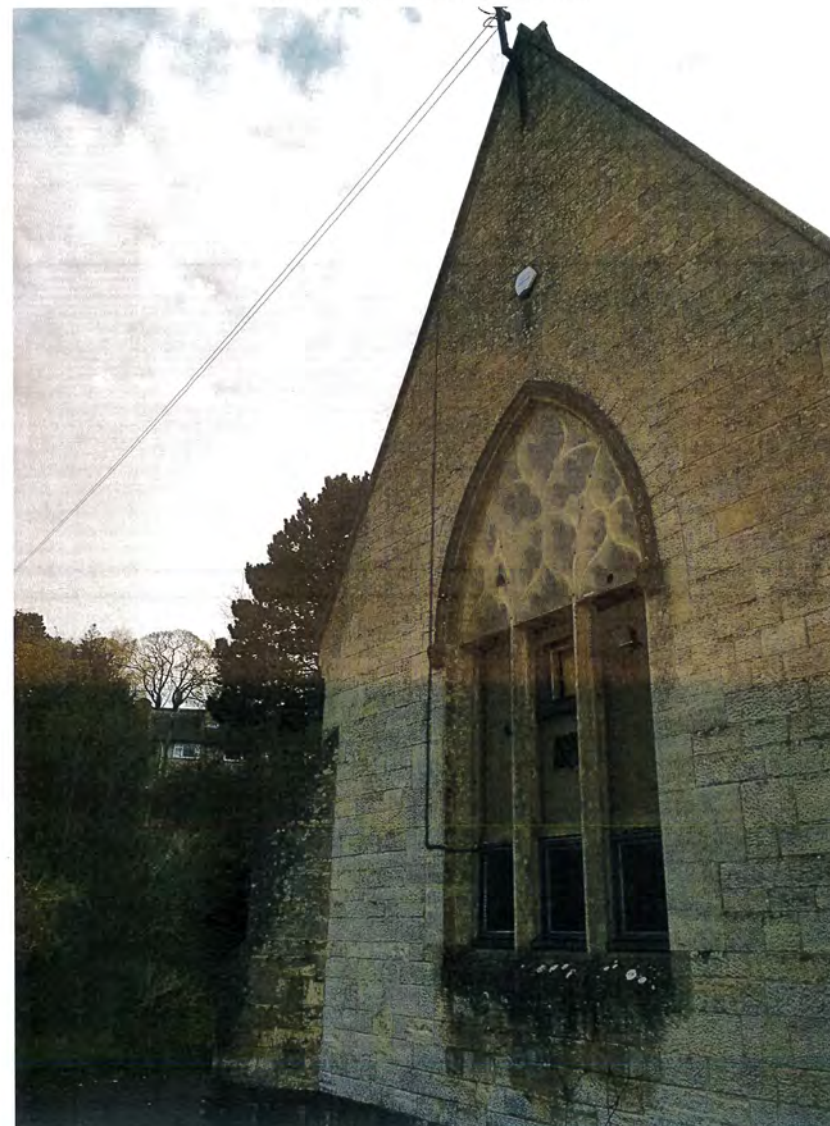
Incoming Electrical Service

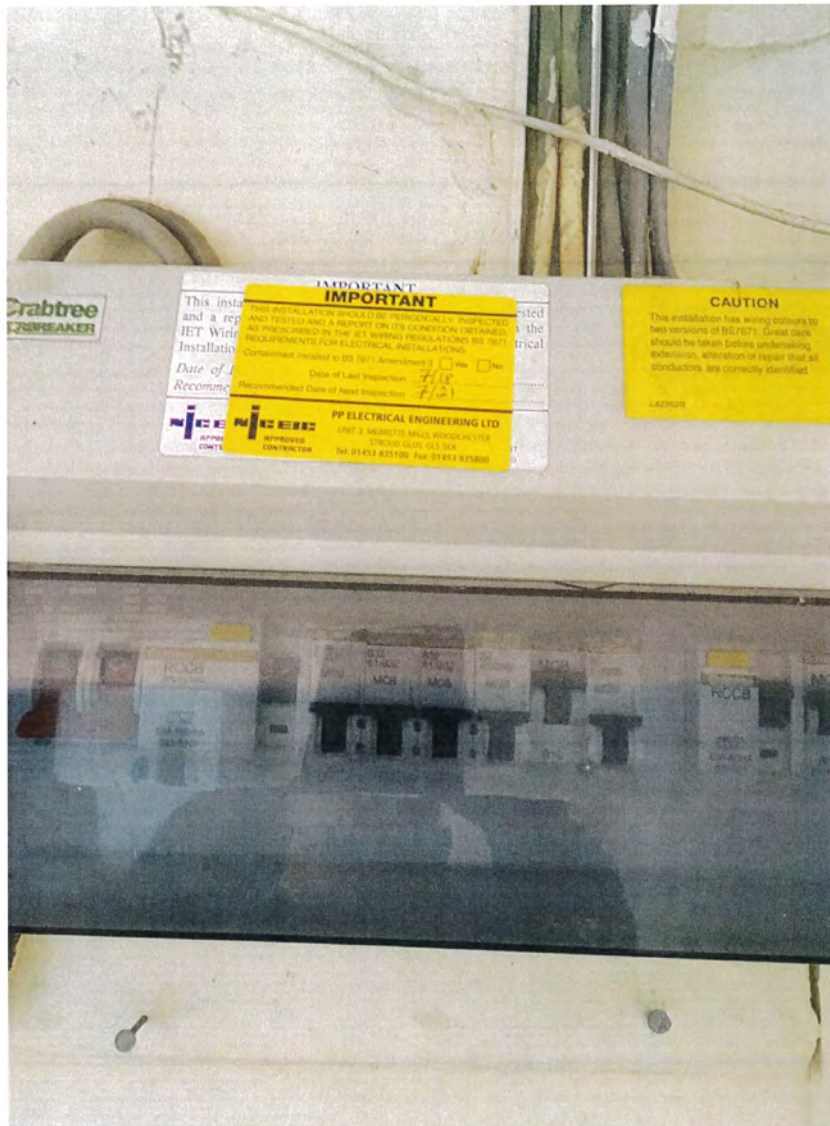
TESTING LABEL: Showing date of next inspection

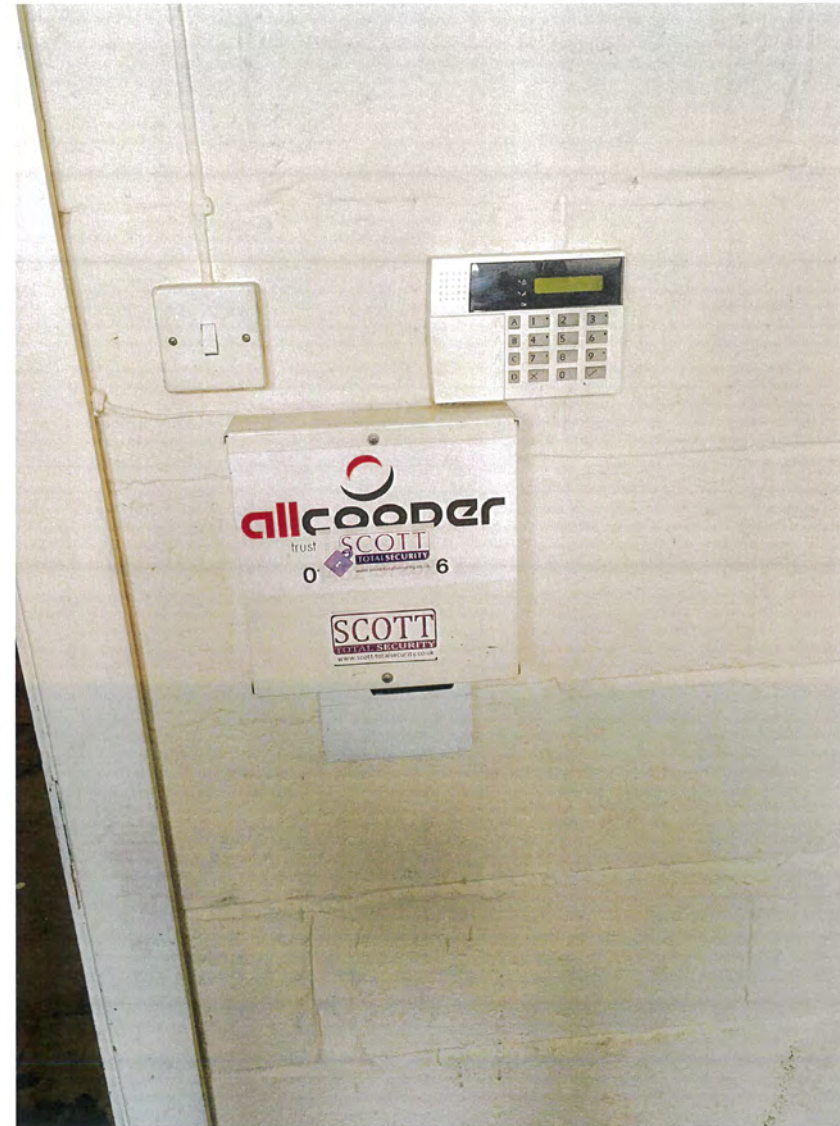
Obsolete Intruder Alarm

- Try to obtain the test sheets for the electrics
- If unavailable, do not use the electrical installation until tested
- Try to obtain the test sheets for the lightning protection system
- Remove any damaged or obsolete electrical items
- Retain the external intruder boxes as a deterrent

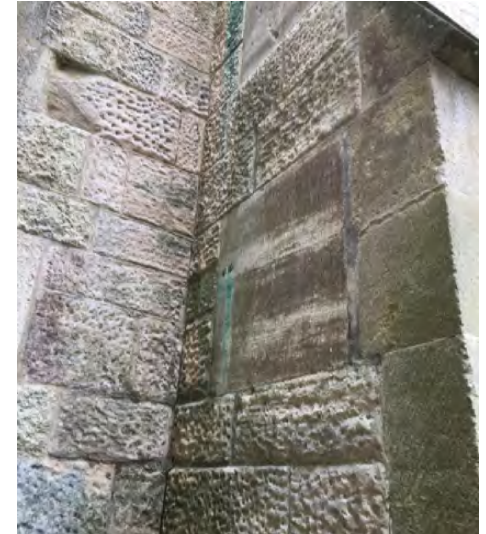
6.

5.2.7 North-east facing elements bear a red stain, thought to be lichen, which does not appear to be harmful to the stone (6).

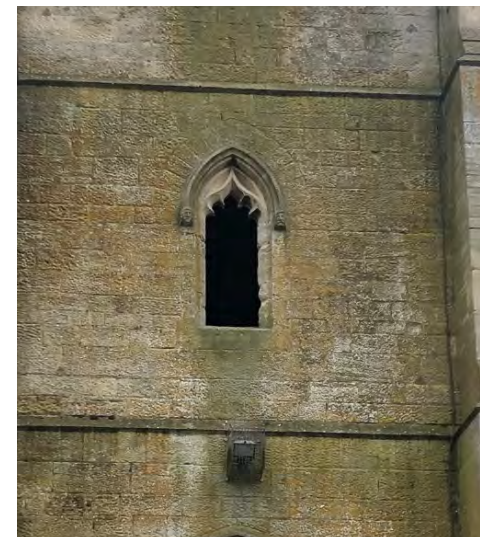
8.

5.2.12 The jambs to the small light to the bell-loft appear to have been badly damaged when the glazing was removed and are likely to require replacement when the opening is reglazed (8).

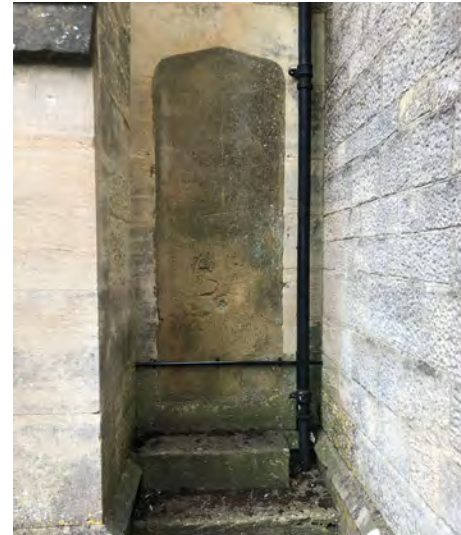
9.

5.2.14 The access to the bell loft within the tower at the north side of the east elevation of the throughway has been blocked and it is again impossible to assess the condition of the jambs (9).

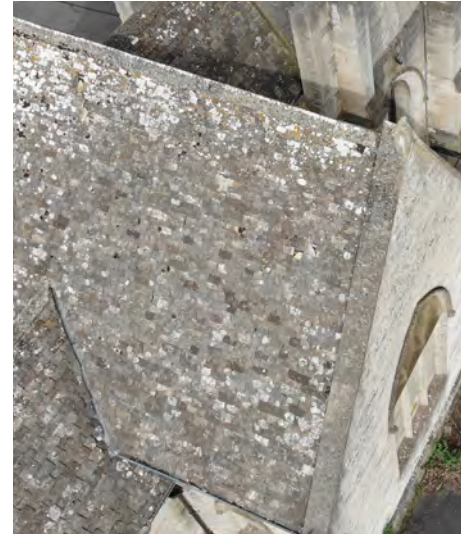
13.

5.3.6 All roofs with stone tiles are in poor condition and in need of relaying (13).

In the longer term, all roofs with stone tiles need to be stripped and recovered. Before then, however, discussions need to be undertaken to decide how these roofs are to be treated and whether there is any benefit in treating the clay-tiled roofs in the same way. Re-laying the roofs would be an opportunity to investigate whether thermal insulation can be introduced, PV or other solar panels integrated on south-facing slopes and whether replacement of the clay tiles, or even turning to using clay tiles or another material on all roofs, might be beneficial.

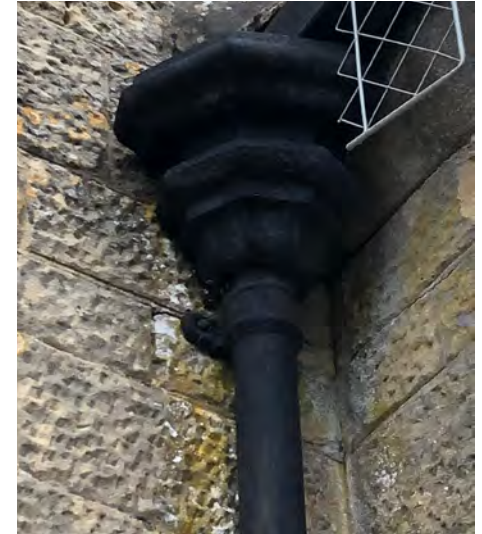
14.

5.3.9 While all rainwater goods would once have been of cast-iron, all gutters are now of uPVC and downpipes a mix of cast-iron, uPVC and aluminium and rainwater hoppers a mix of cast iron (14) and uPVC.

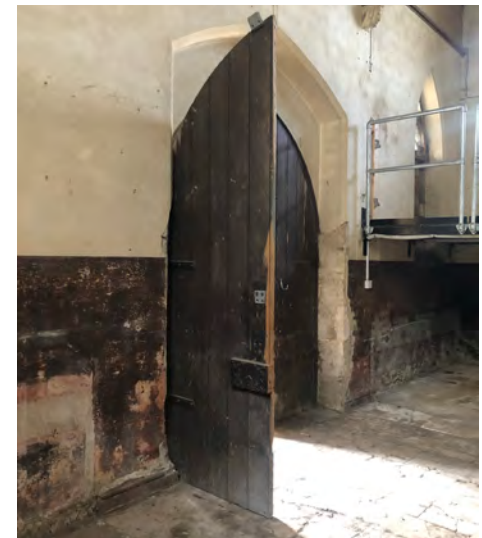
16.

5.4.4 The inner pair of doors to the south chapel are original, retaining their original hinges and lock, but are in a poor state of repair (16), though repairable, while those to the north chapel are modern replicas in good condition, though not retaining original ironmongery. Both sets retain their original frames.

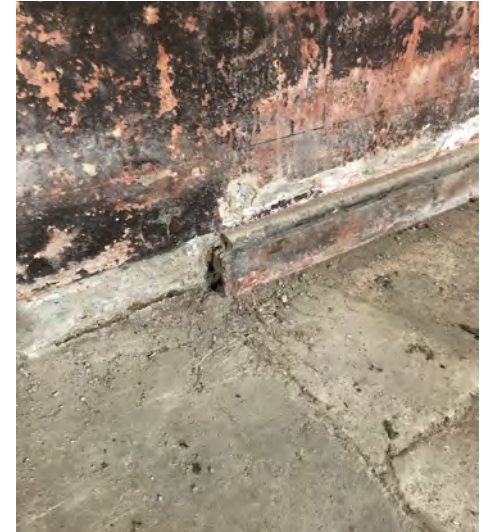
18.

5.5.1 The internal walls were originally finished in lime plaster with a run render skirting (18).

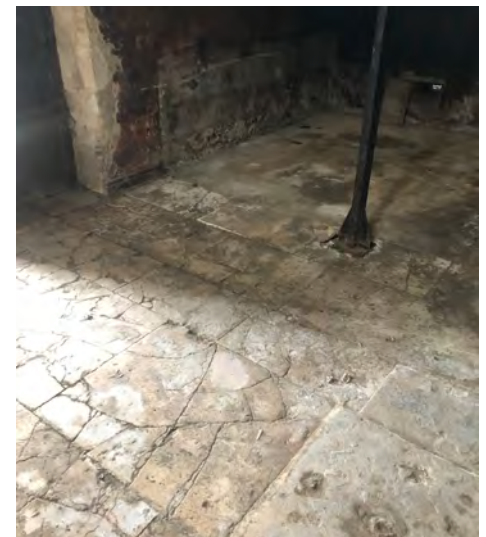
20.

5.5.10 The stones are in poor condition, being severely cracked in places (20), while the screed is generally intact.

When it comes to the floors, their poor existing condition would probably lead to permission to replace them being granted. We would argue against a conventional concrete slab with damp proof membrane, as that would result in ground moisture being driven up into the walls with unwanted consequences. Instead, a Limecrete system could be employed, subject to the building's footings being at a suitable depth to avoid being undermined by the necessary excavation. Using blown glass insulation and lime-based binder, it is possible to produce a floor which can naturally transpire, provide a significant thermal upgrade, incorporate underfloor heating and allow a variety of more suitable floor finishes to be used.

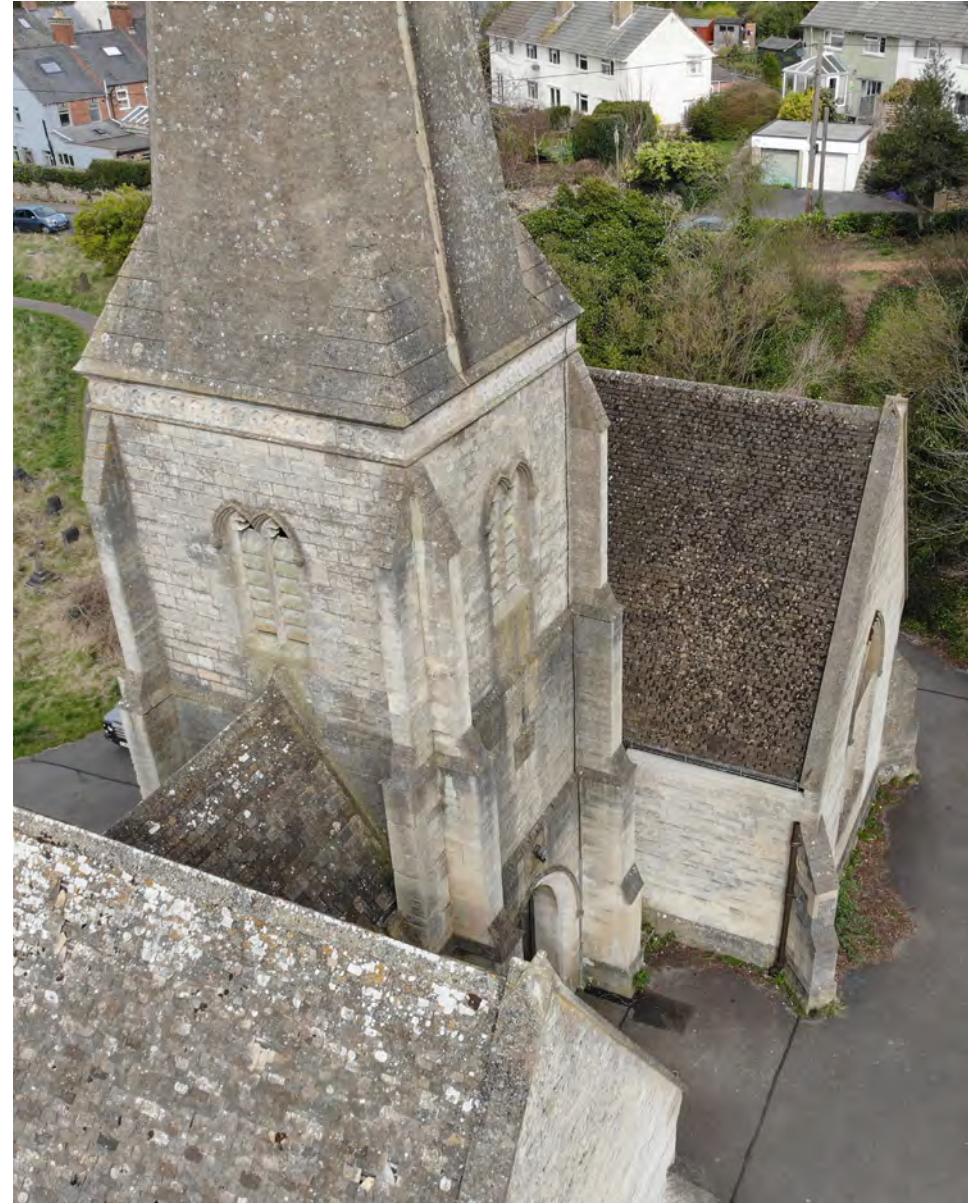
21.

Unfortunately, the condition of the roofs is not as good as the masonry and all those covered in stone tiles are reaching the end of their useful lives. While wholesale replacement of these roofs would be ideal, it should be possible to undertake one final round of patching to make the roofs watertight for the next five years. As for those roofs with clay tiles, they would benefit from some patching at this juncture, replacing broken or slipped tiles, though they are in far better overall condition (21).

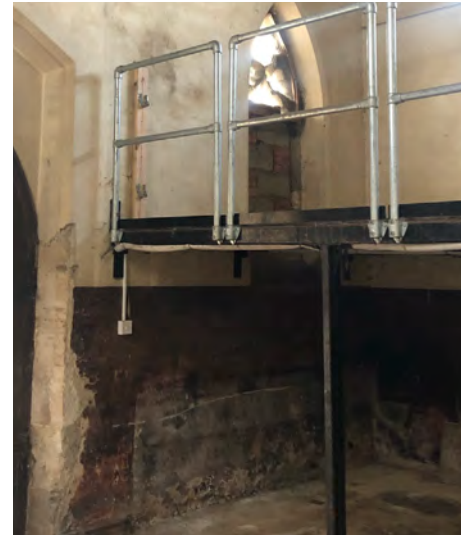
23.

The way in which the part mezzanines have been inserted is unfortunate, as they bear on the existing wall structures inflicting inevitable, albeit minor damage (23). Should it be decided that such interventions are required, it would be preferable to see new structures which rely purely on support off the floors. Similarly, modern blockwork partitions and over-screeded flooring (24) have negatively impacted the historic fabric and, should similar be required in future, less harmful solutions ought to be considered.

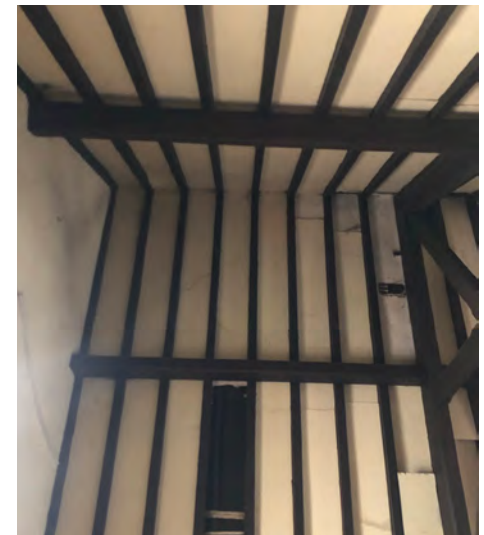
26.

Due to their design, improving the thermal performance of the roofs is not a straightforward task. If a 'thick' roof finish, such as stone tiles, is retained, the addition of insulation above the rafters is severely restricted due to the tight-fitting copings to the gables (25) and projecting stone mouldings at abutments. To only insert insulation between the rafters would result in 'cold-bridging', reducing the advantages otherwise brought by the insulation and potentially creating interstitial condensation issues, while the addition of insulation beneath the rafters would probably be resisted by the Conservation Officer, particularly in the north chapel where most of the original ceiling fabric remains (26).
