Donald Insall Associates
Chartered Architects and Historic Building Consultants

Stroud Chapels of Rest - Feasibility Assessment

September 2021

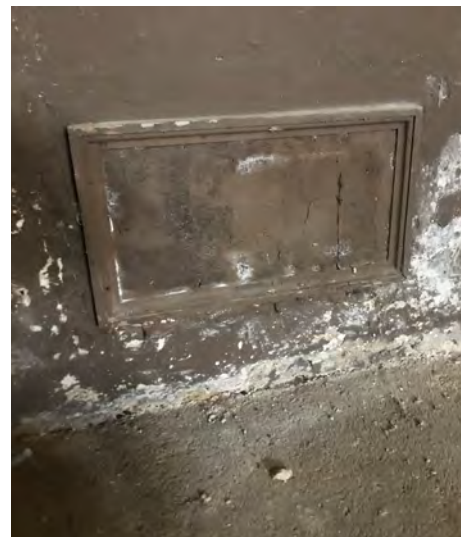
7.

5.2.10 The gable ends of each chapel incorporate low-level air-bricks, which are modern fireclay replacements for, in all probability, original cast-iron fittings (7).

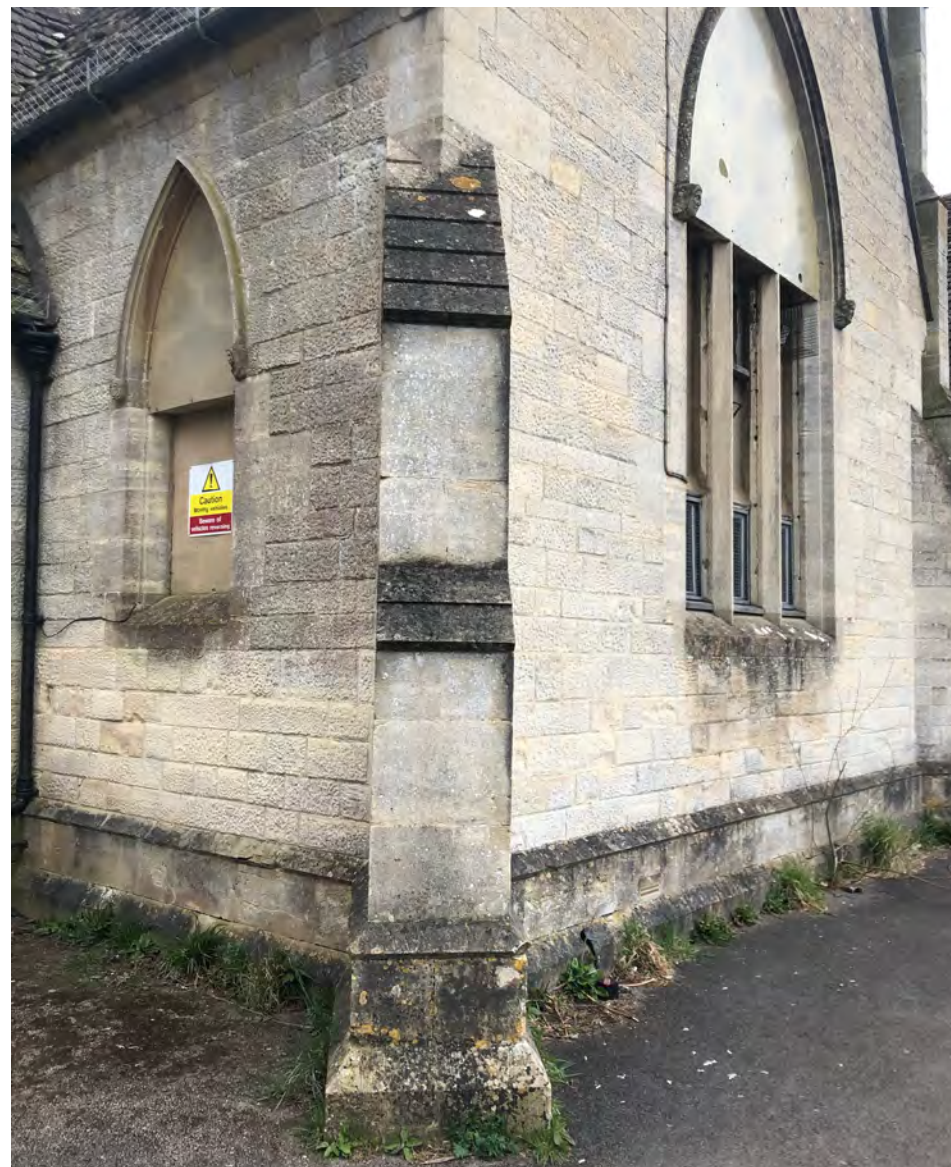
27.

If it is decided to insulate, the addition of external insulation is impossible, as the preservation of building's handsome appearance is essential (27), while the addition of insulation of some kind to the internal surface presents various issues, none less than gaining the approval of the Conservation Officer.
